**USAAVLABS TECHNICAL REPORT 68-38C**  
**RADIAL OUTFLOW COMPRESSOR COMPONENT DEVELOPMENT**  
**VOLUME III**  
**PHASE III - MECHANICAL DESIGN AND EXPERIMENTAL**  
**INVESTIGATION USING MODIFIED ROTOR**

**By**  
**John R. Erwin**

**August 1969**

**CONTRACT DA 44-177-AMC-180(T)**  
**GENERAL ELECTRIC COMPANY**  
**CINCINNATI, OHIO**

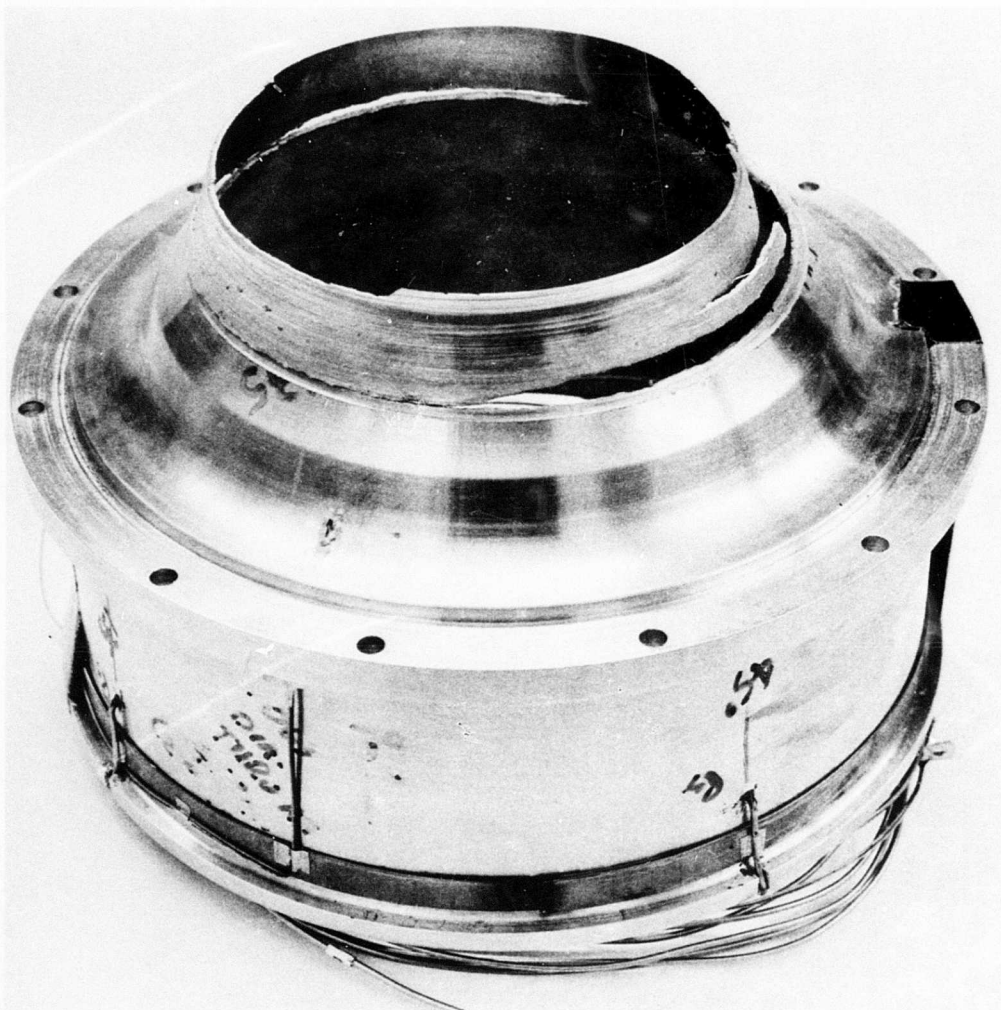
Figure 30. Bellmouth Liner and Fractured Ring Following Run 19 of Buildup A, Phase III Investigation.

The rotor with the aluminum ring attached to it is shown in Figure 27. A view of the broken ring after it had been removed from the rotor (with some difficulty) is shown in Figure 28. The liner after the fracture is shown in Figures 29 and 30.

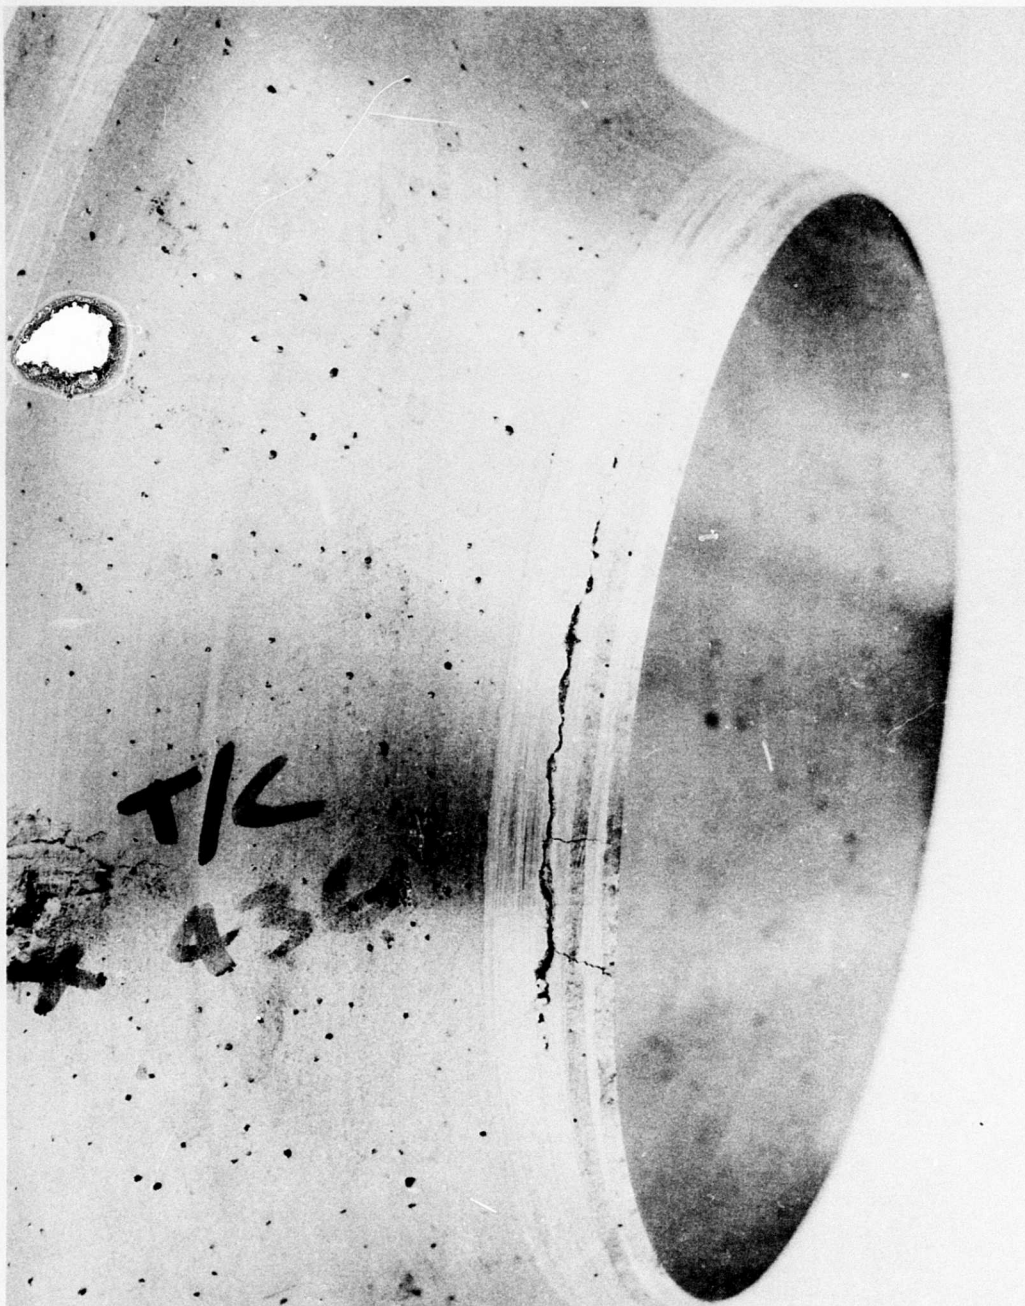
Figure 35. Close-up of Fracture in Cast Bellmouth Liner.

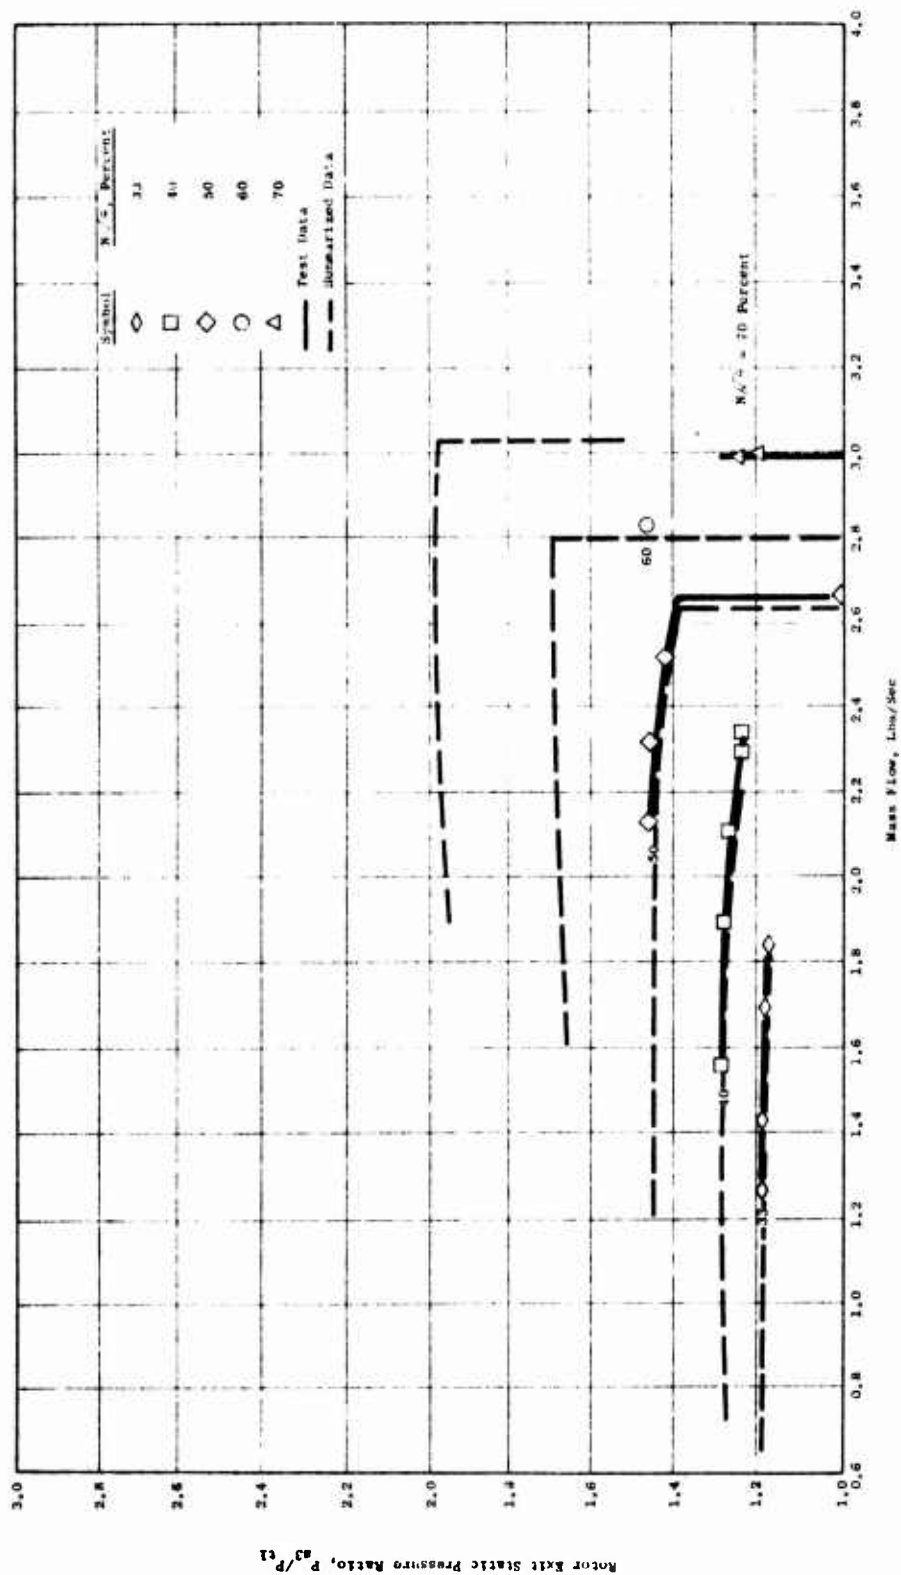
Figure 70. Static Pressure Ratio Versus Mass Flow With Supersonic Stators Set at 76 Degrees and Subsonic Stators Set at 73 Degrees.

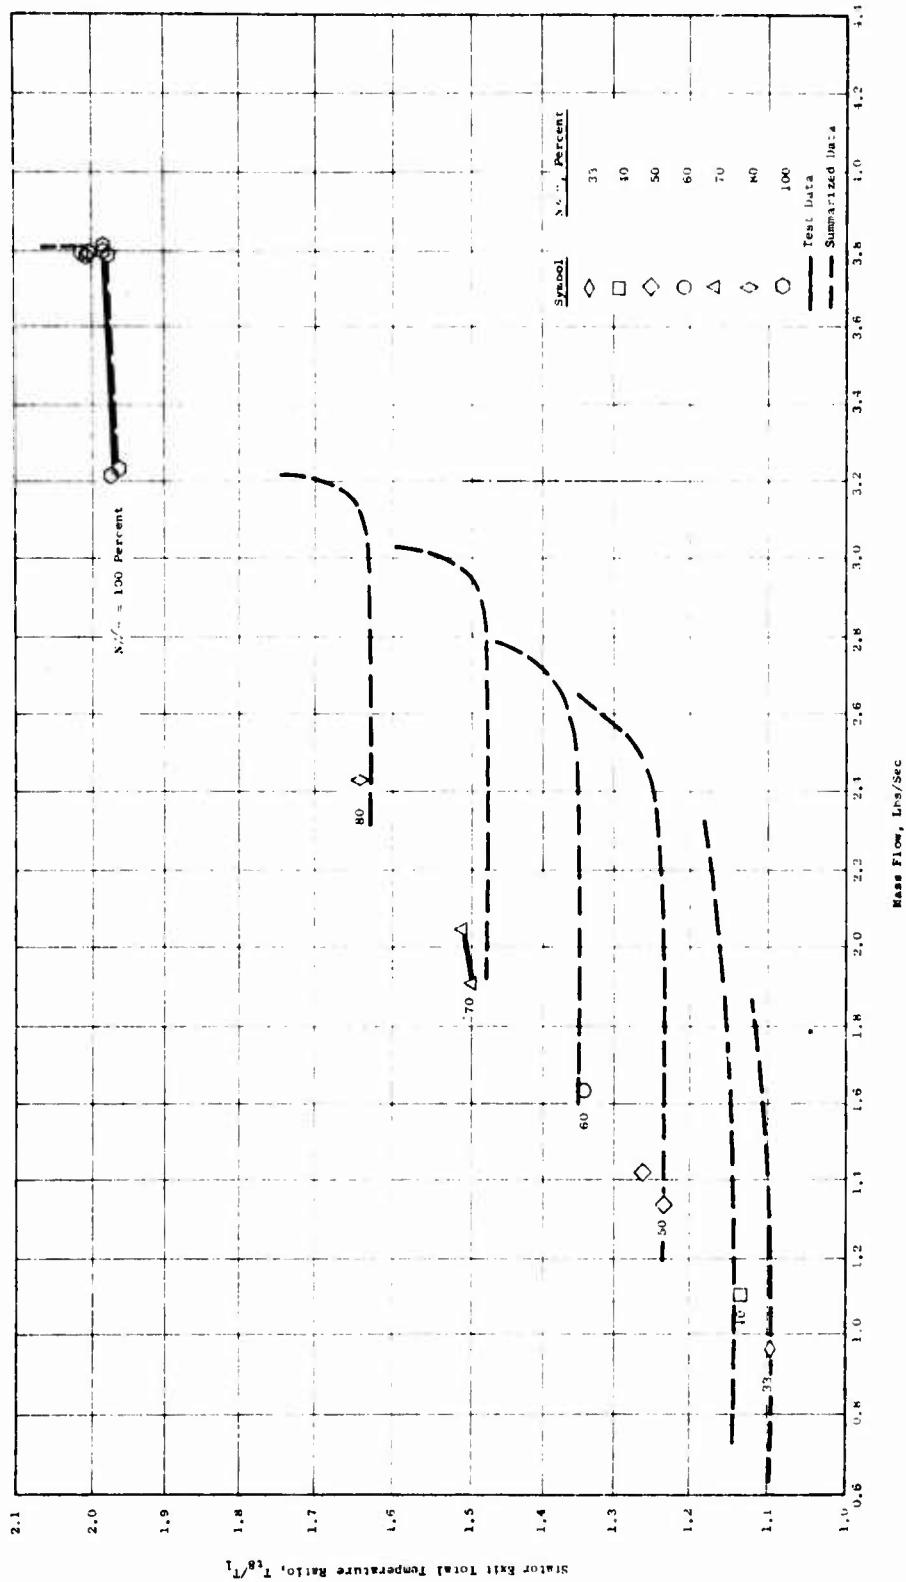
Figure 91. Total Pressure Ratio Versus Mass Flow for Predicted and Summarized Data.

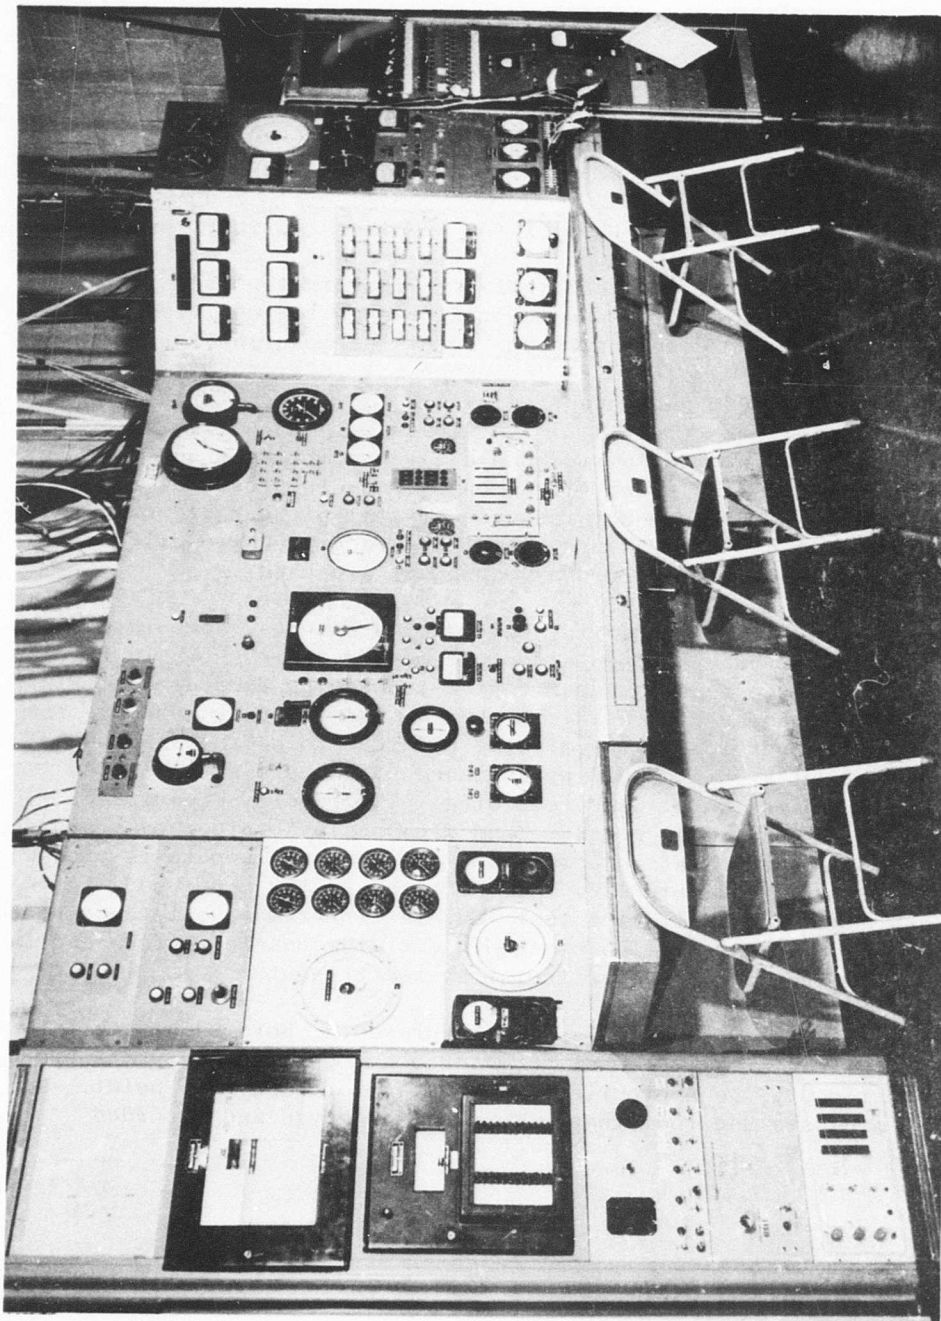
Figure 112. Central Control Panel Used for Control and Indication of ROC Speed, Throttle Setting, Stator Vane Angle, and Indication of Vehicle Vibrations and Bearing Temperatures.
